INSTALLATION RESTORATION PROGRAM

COLORADO AIR NATIONAL GUARD
BUCKLEY AIR NATIONAL GUARD BASE, AURORA, COLORADO

REMEDIAL INVESTIGATION REPORT VOLUME I

August 1995

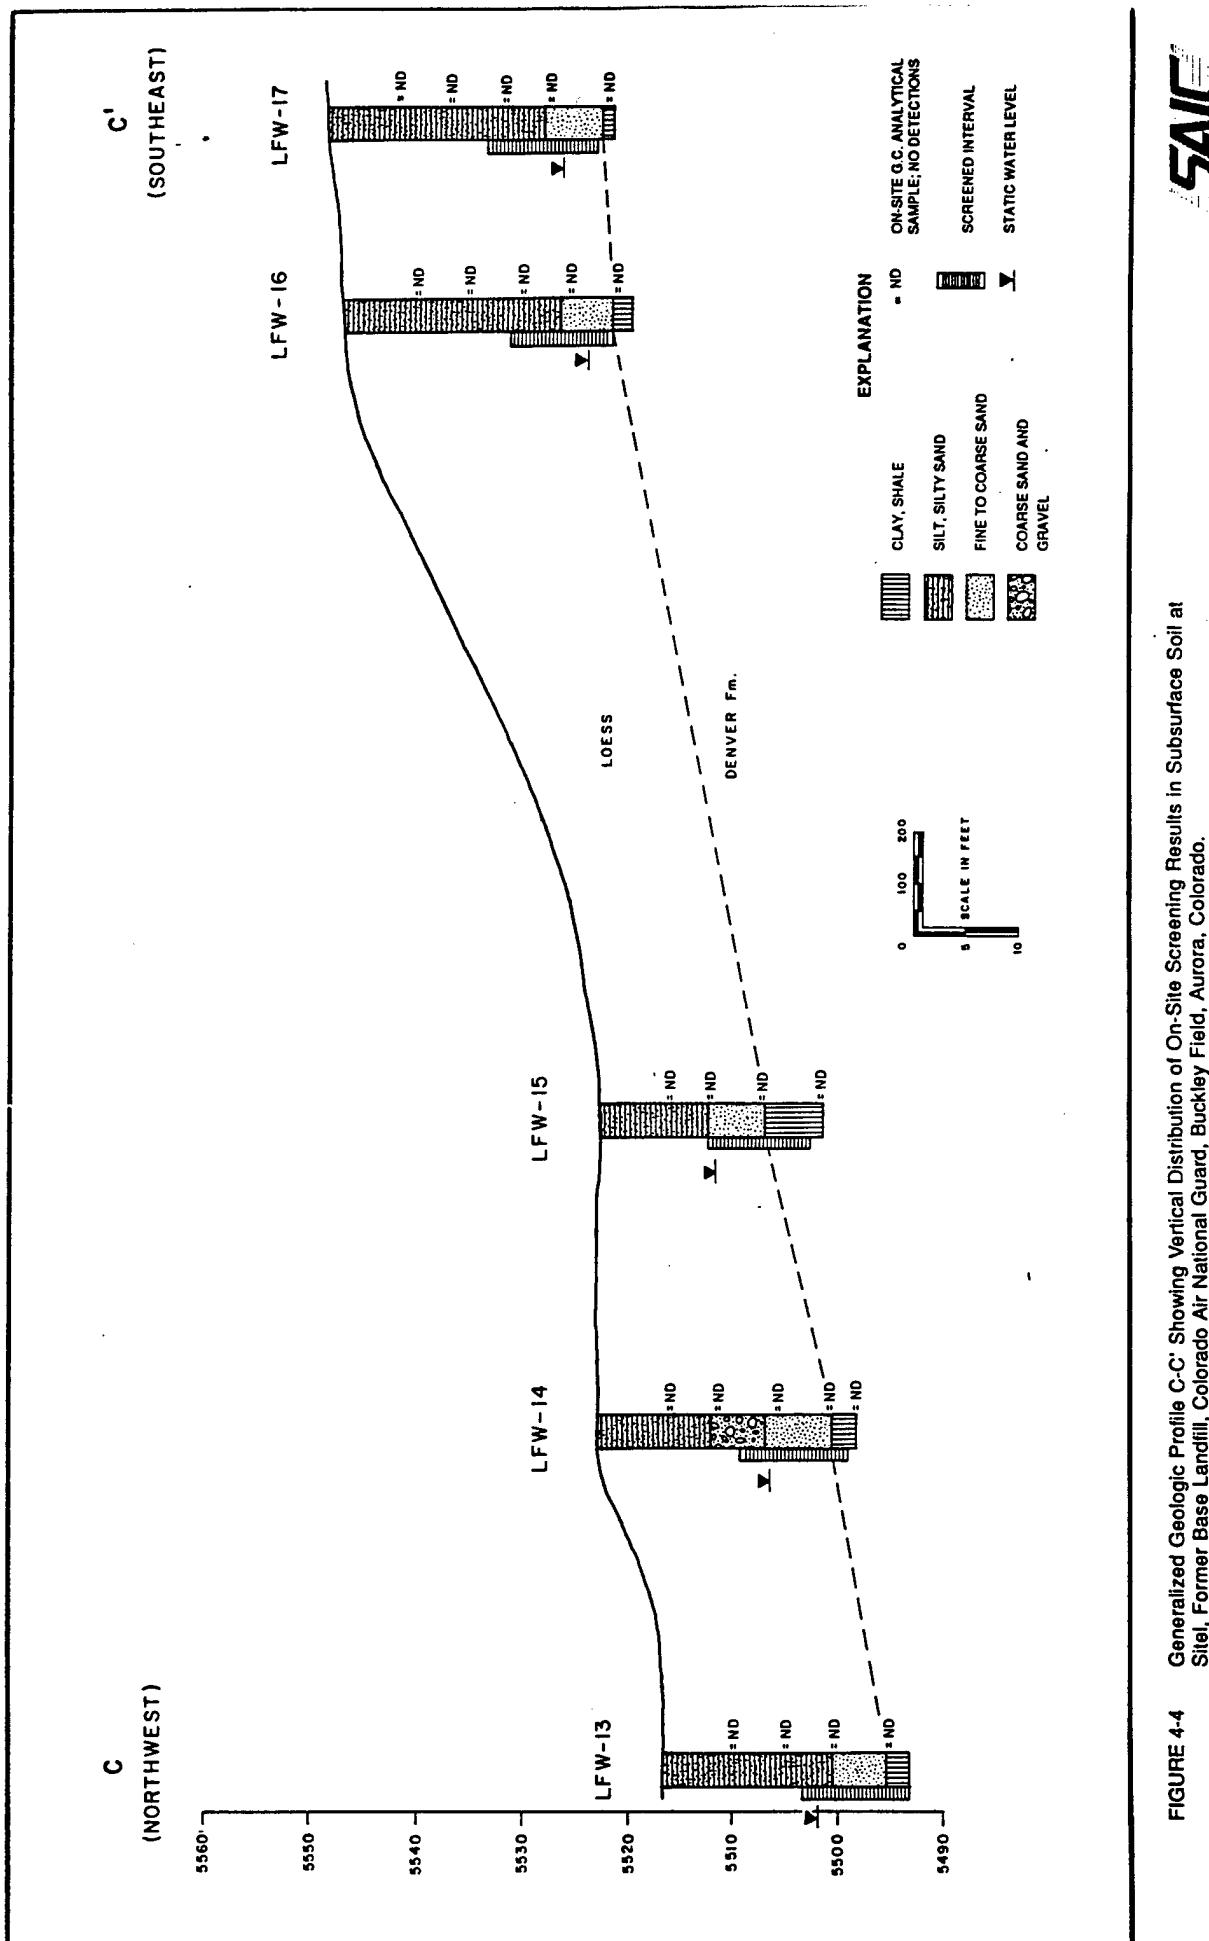
FIGURE 4-4

Generalized Geologic Profile C-C' Showing Vertical Distribution of On-Site Screening Results in Subsurface Soil at Site 1, Former Base Landfill, Colorado Air National Guard, Buckley Field, Aurora, Colorado.

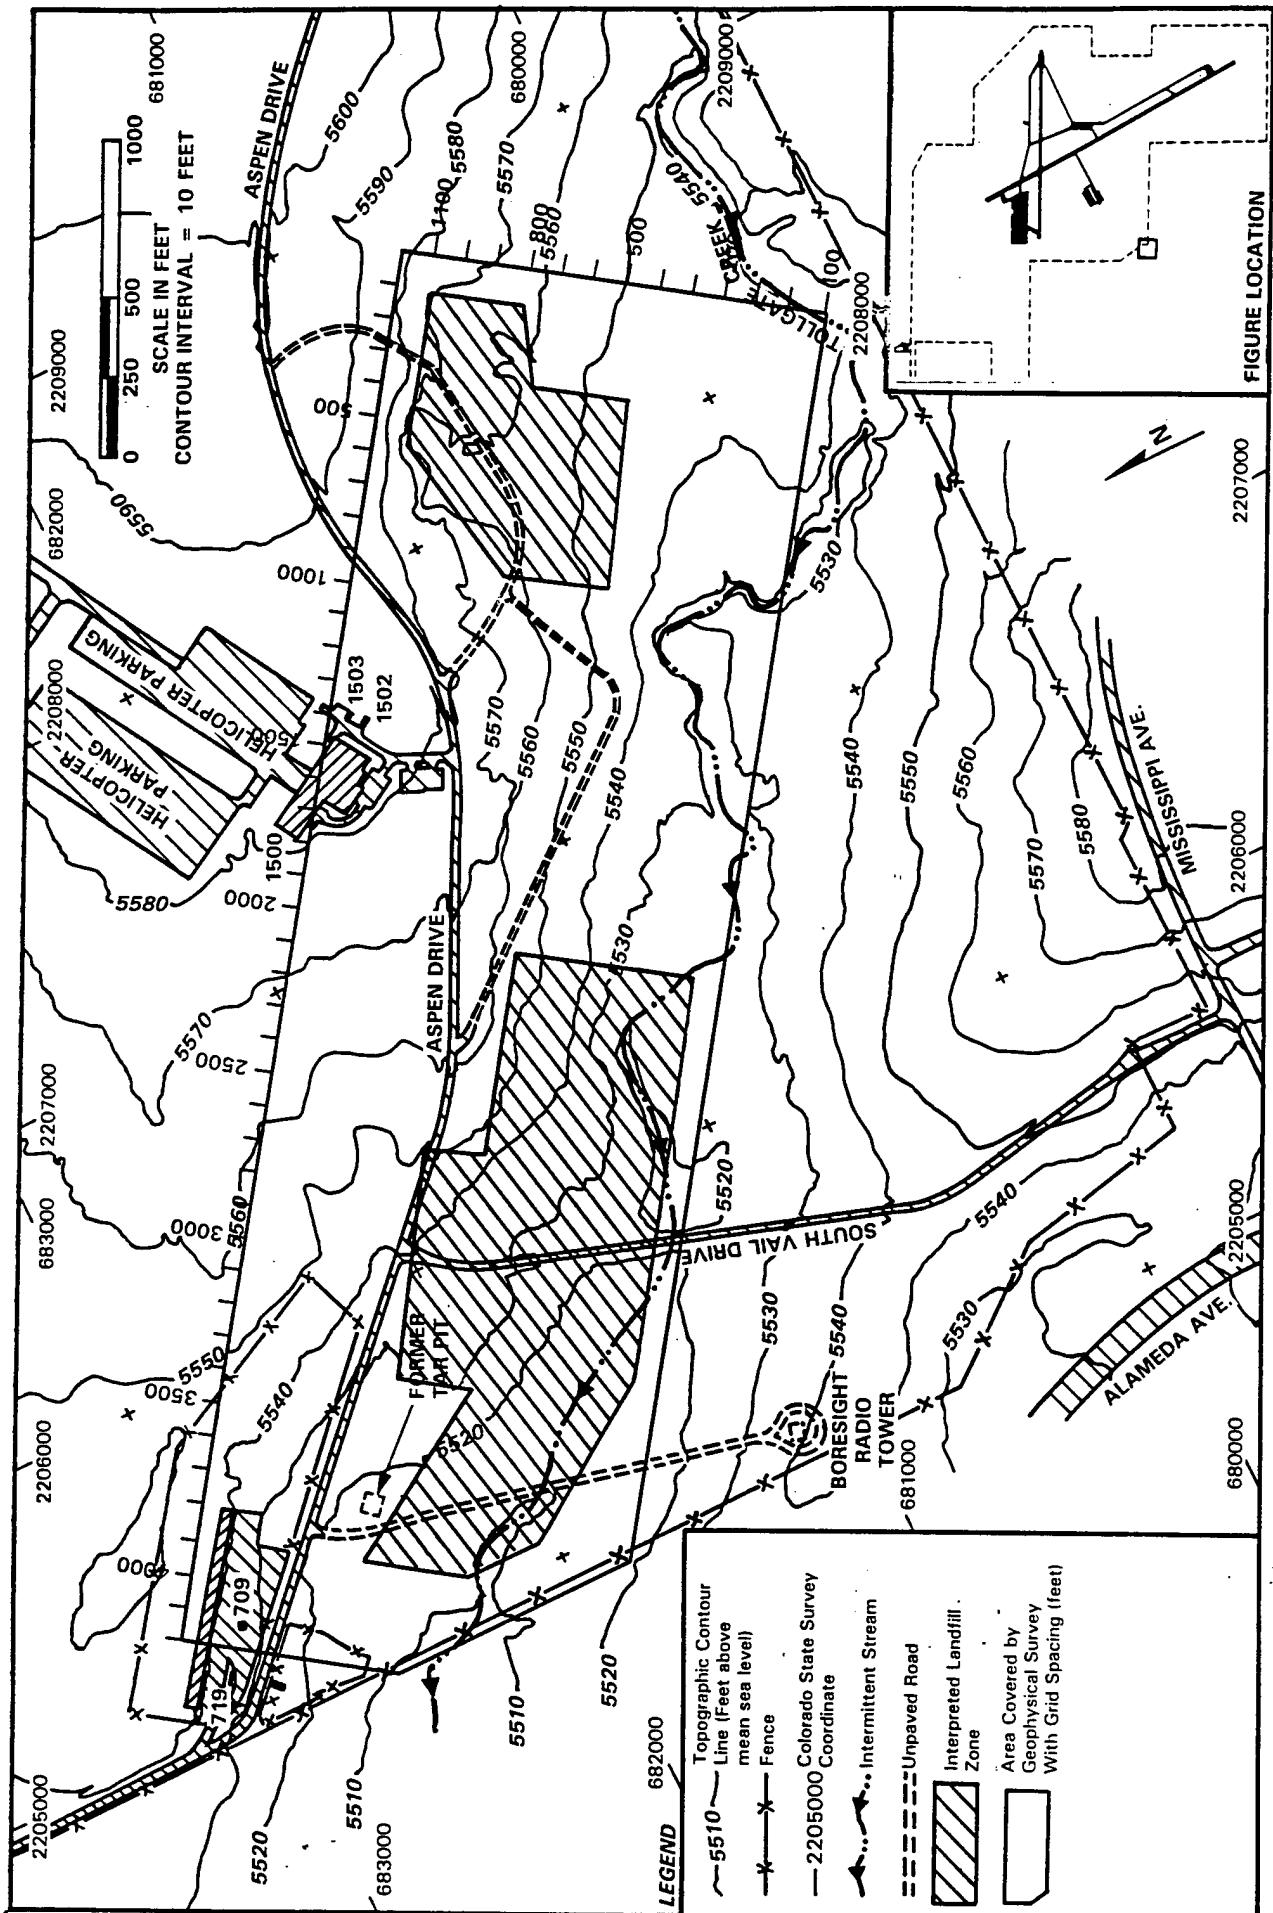
Another region at Site 1 exhibited some anomalous characteristics, which may not be caused by buried landfill debris. Transect profiles 1300 to 2100 show short, abrupt apparent conductivity changes, but the variations are not laterally continuous between transects. The in-phase data show little variation along these transect profiles, indicating that no buried metal objects exist in this area, and that the apparent conductivity variations may be caused by something other than buried landfill debris. The area traversed by these transects is covered with surface dirt piles which may have contributed to the conductivity variations because of topographic effects, or the disturbed soil in the piles may have caused anomalously low apparent conductivity results due to air pockets in the soils or a combination of the two.

Figure 4-7 Locations of Interpreted Landfill Zone From The Surface E.M. Conductivity Survey at Site-1, Former Base Landfill, Colorado Air National Guard, Buckley Field, Aurora, Colorado

The contour and profile results of conductivity and in-phase data suggest two anomalous regions possibly caused by landfill debris, at the Former Base Landfill Area. Figure 4-7 shows the location of these two suspected areas. The two regions, one to the east of South Vail Drive, and one near the northeast corner of the site, show strong indications of buried metal objects, possibly metal drums. Other anomalous regions were sporadically located throughout the area indicating that landfill operations possibly spread or dumped debris over many parts of the site.

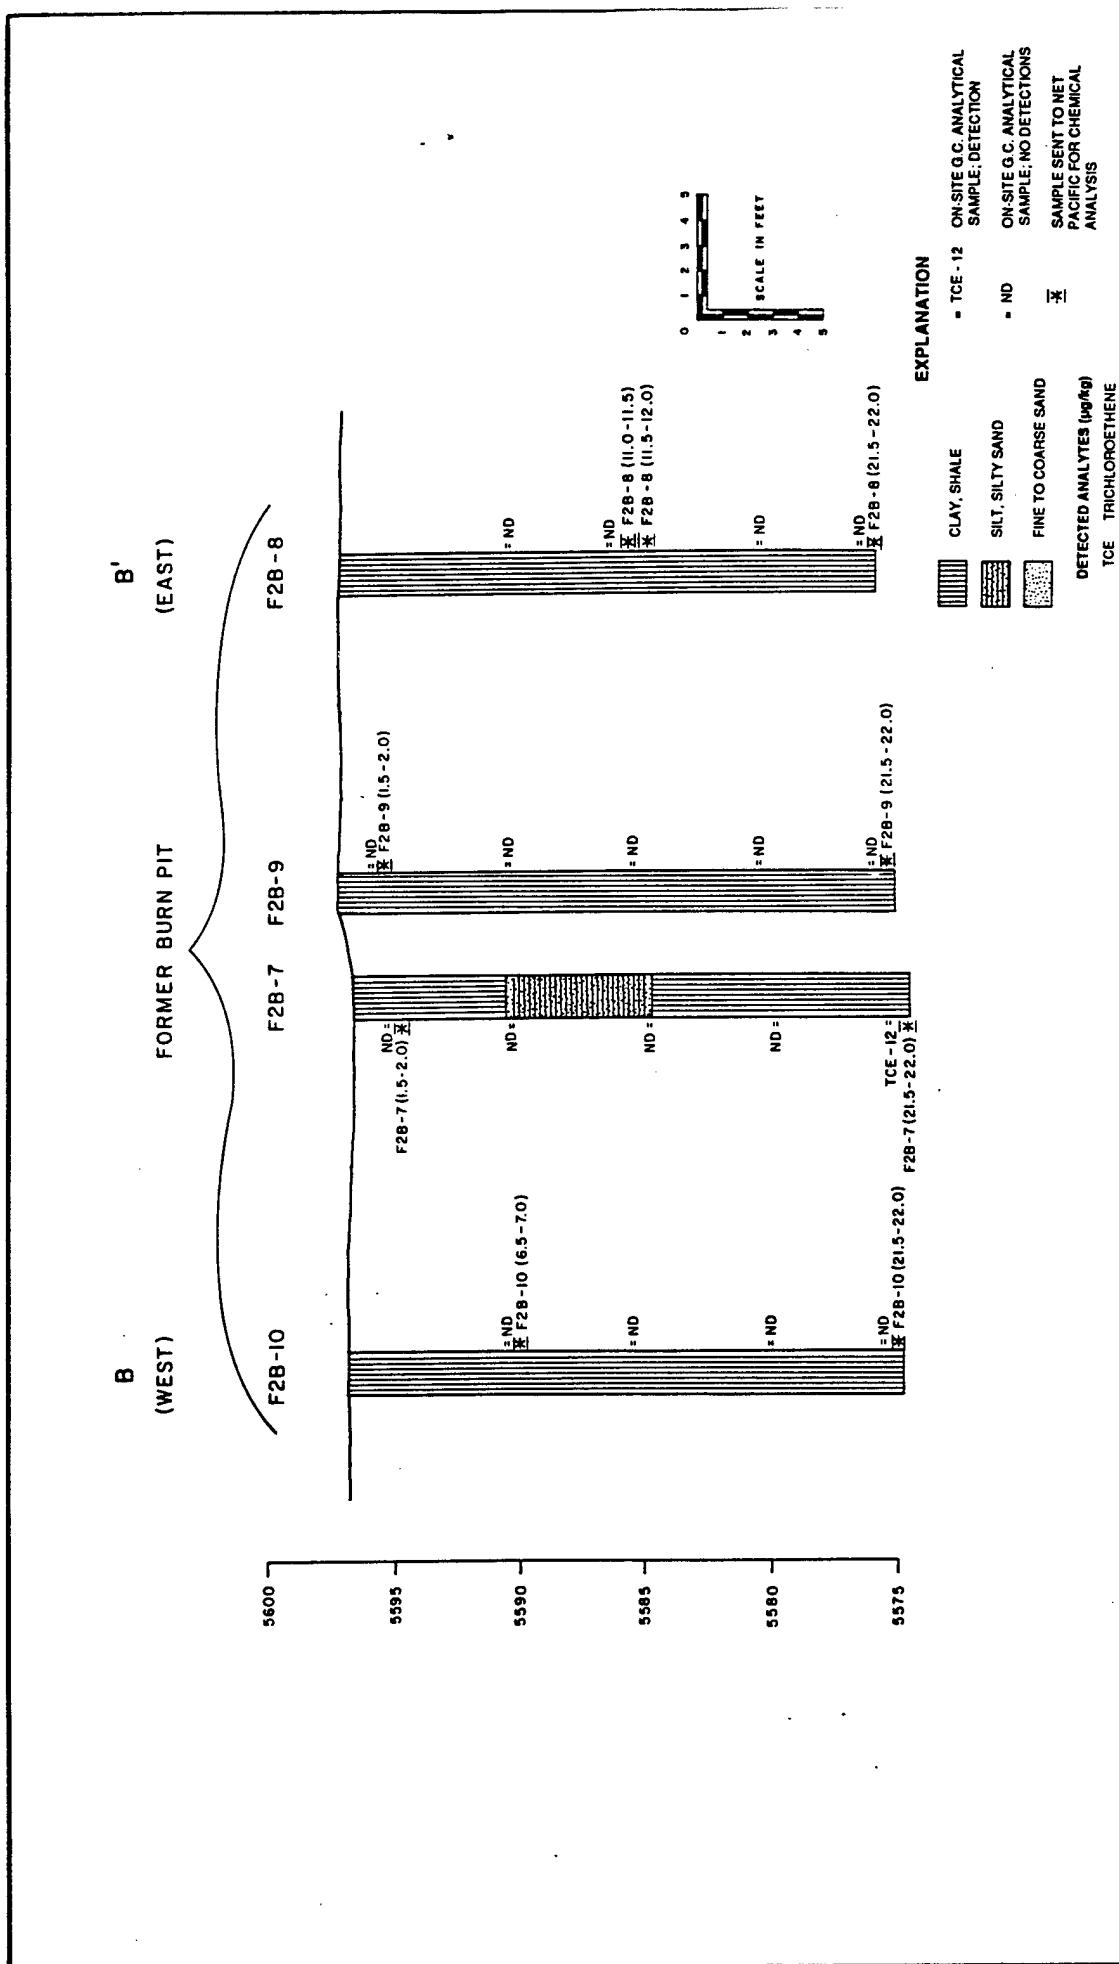
Generalized Geologic Profile B-B' Showing Vertical Distribution of On-Site Screening Results in Subsurface Soil (light gray) at Site 3, Farmer Fire Training Area No. 2, Colorado Air National Guard, Aurora, Colorado.

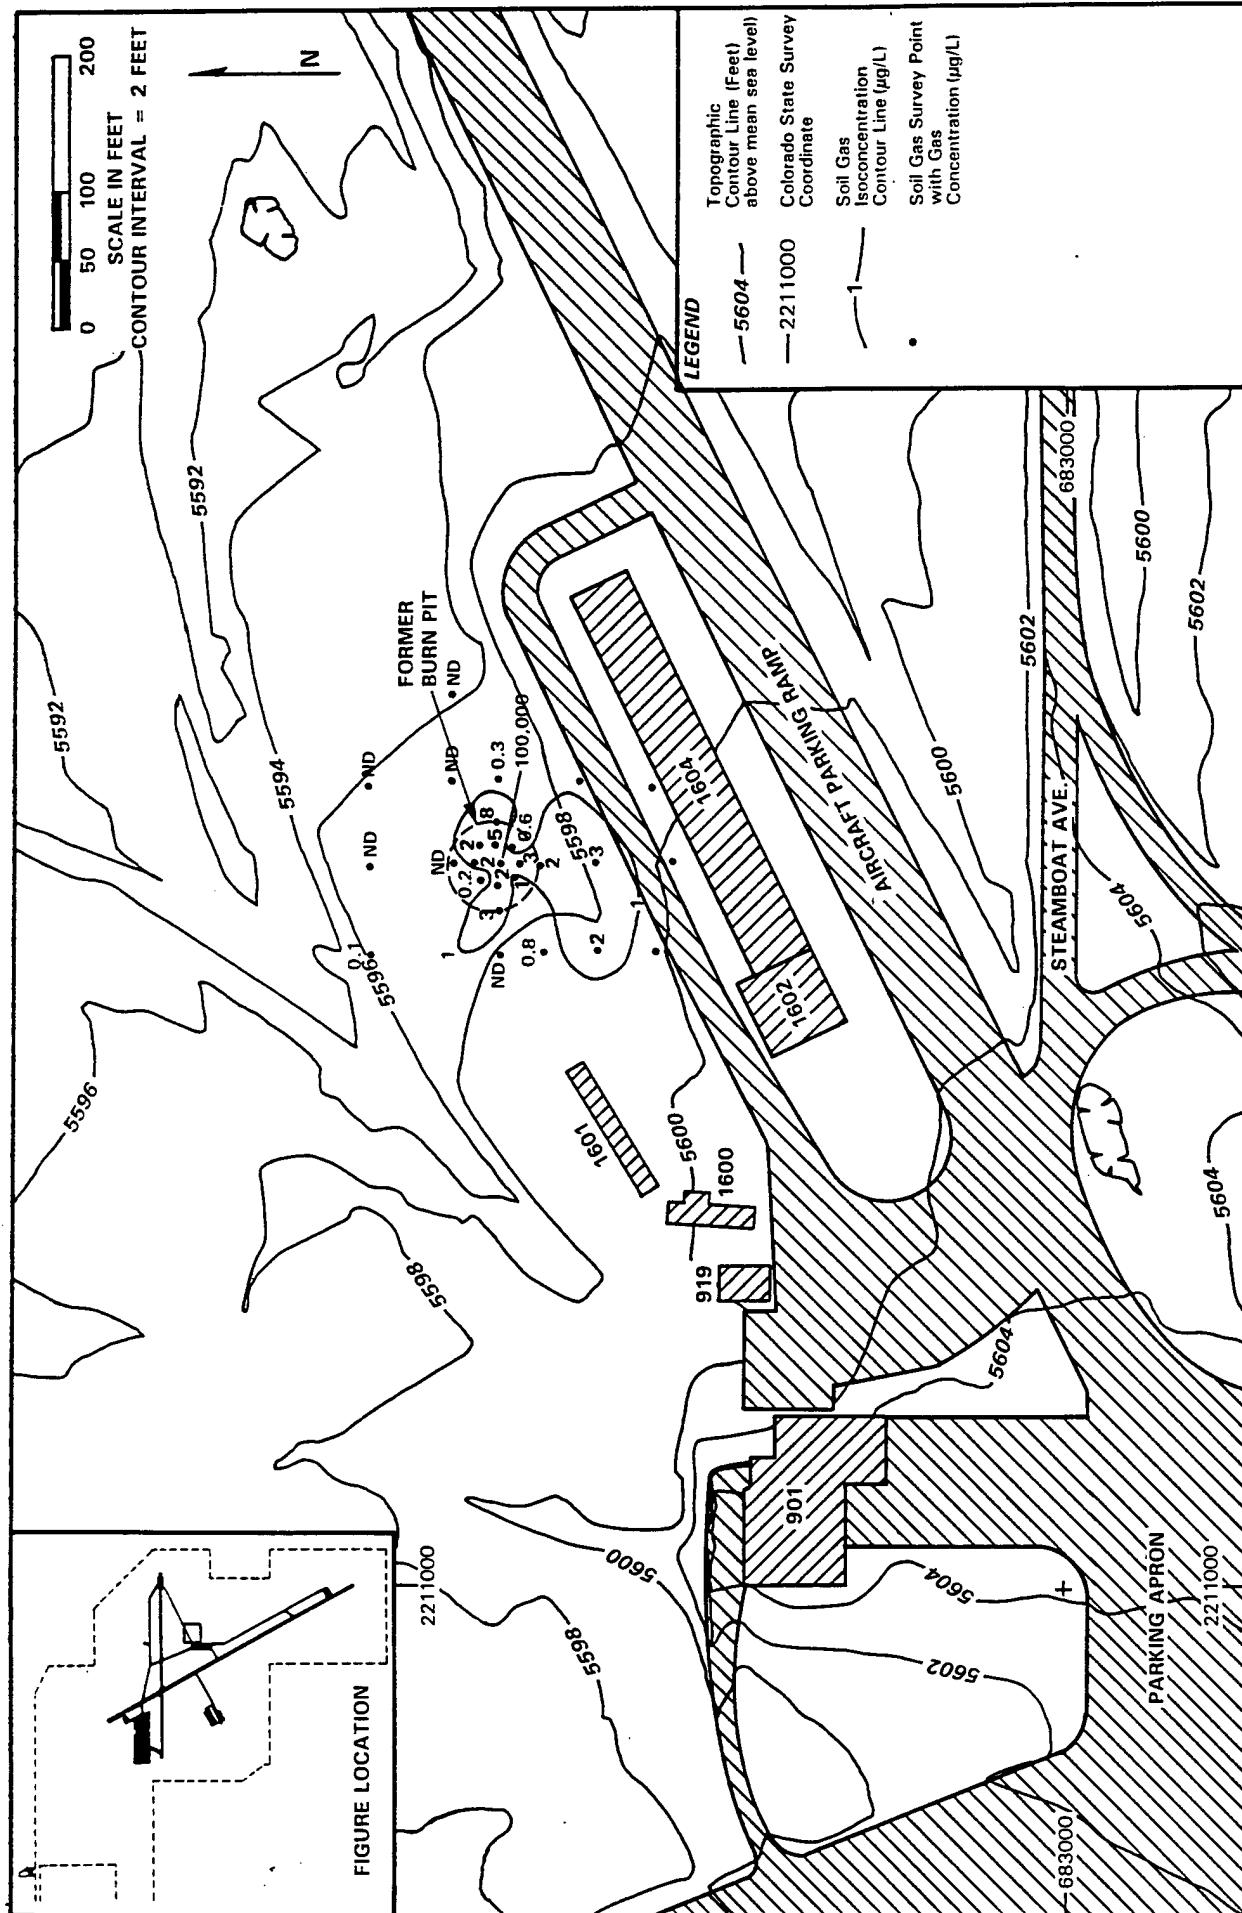
The soil-gas survey detected elevated (relative to background) concentrations of petroleum-related contamination within a radius of approximately 25 feet in the former burn pit area. Lower concentrations were detected in an irregular pattern up to 50 feet from the burn pit area. This pattern may be due to regrading and spreading of the soils surrounding the fire pit during abandonment, or to volatile contaminant migration through the soil gases. Volatile organic compounds were detected in one soil boring (F2B-6) located in the burn pit area above the 10-foot below land surface (BLS) depth. Deeper soil samples from this boring, as well as samples collected from the other four boreholes drilled within the former burn pit and soil samples collected during drilling of three monitoring wells, indicate that contaminants are probably not migrating deeper into the soil. No site-related contamination was found within groundwater samples taken at the site.

Figure 6-5 Soil Gas Isoconcentration Contour Map of Total Hydrocarbons for Site 3- Former Fire Training Area No. 2, Colorado Air National Guard, Buckley Field, Aurora, Colorado

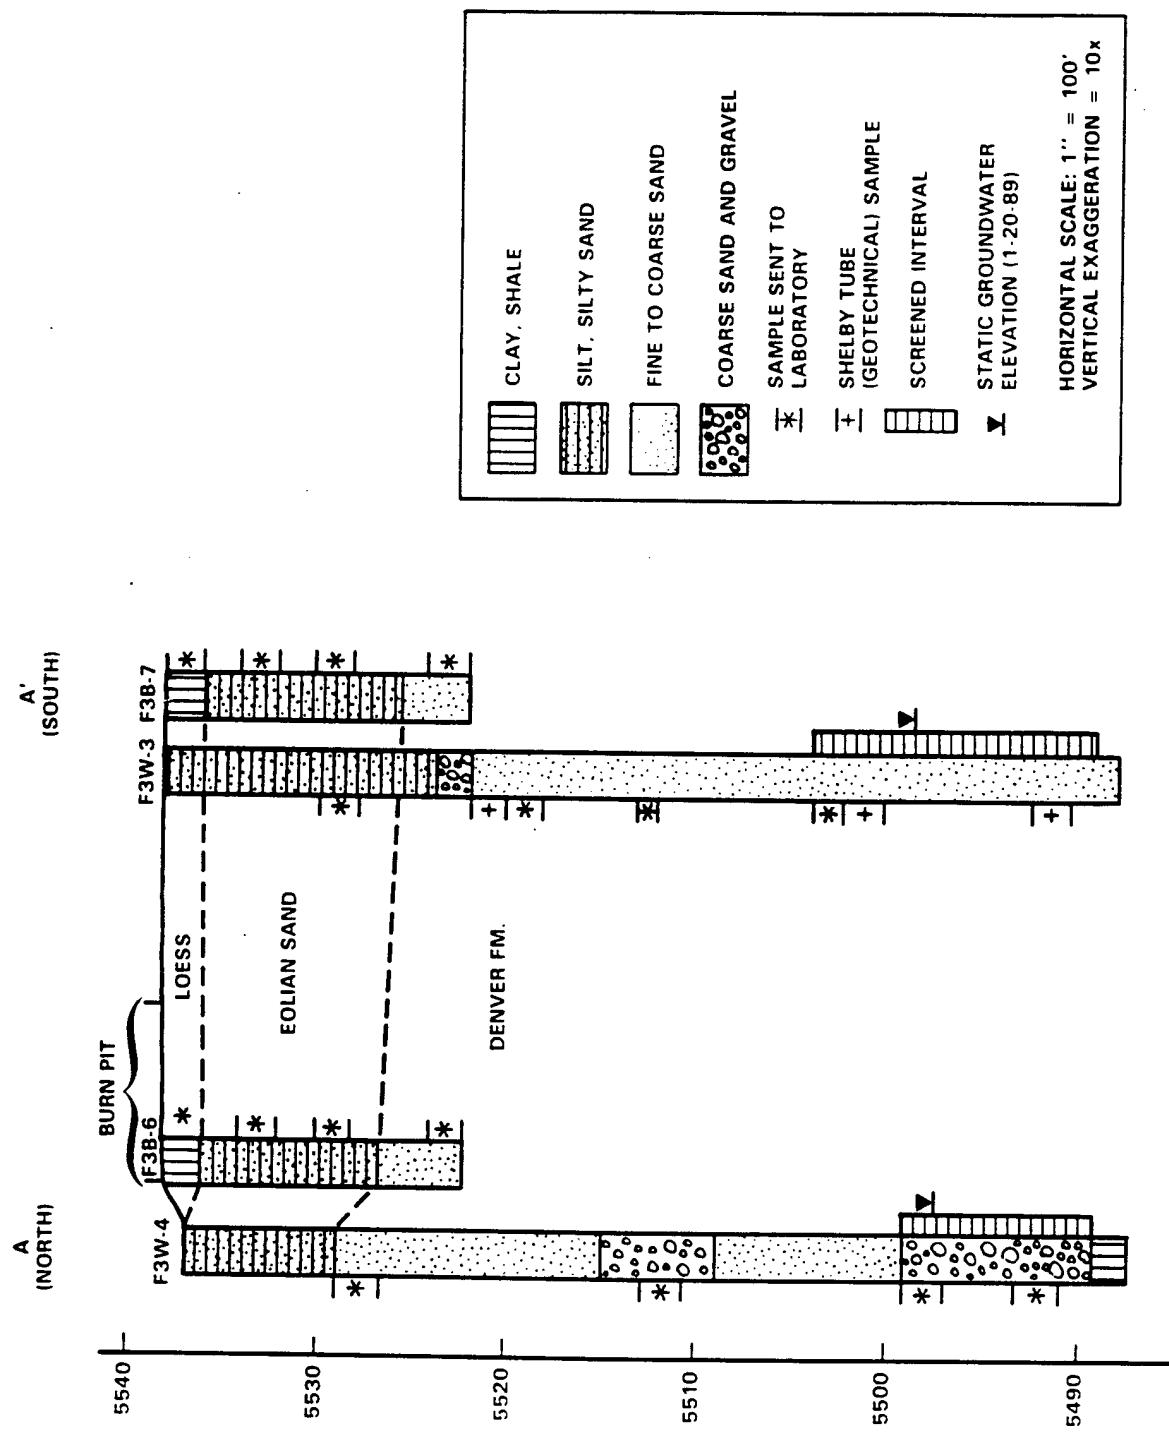
Figure 7-2 Generalized Geologic Profile A-A' of Site-4, Fire Training Area No. 3, Colorado Air National Guard, Buckley Field, Aurora, Colorado.

The deposits encountered during drilling at this site were the coarsest of any found on base. Underneath a thin 3-ft layer of loess were greater than 45 ft of sand, gravel, and some silt (Figures 7-2, 7-3, 7-4 and 7-5). These deposits, which comprised the thickest continuous bed of

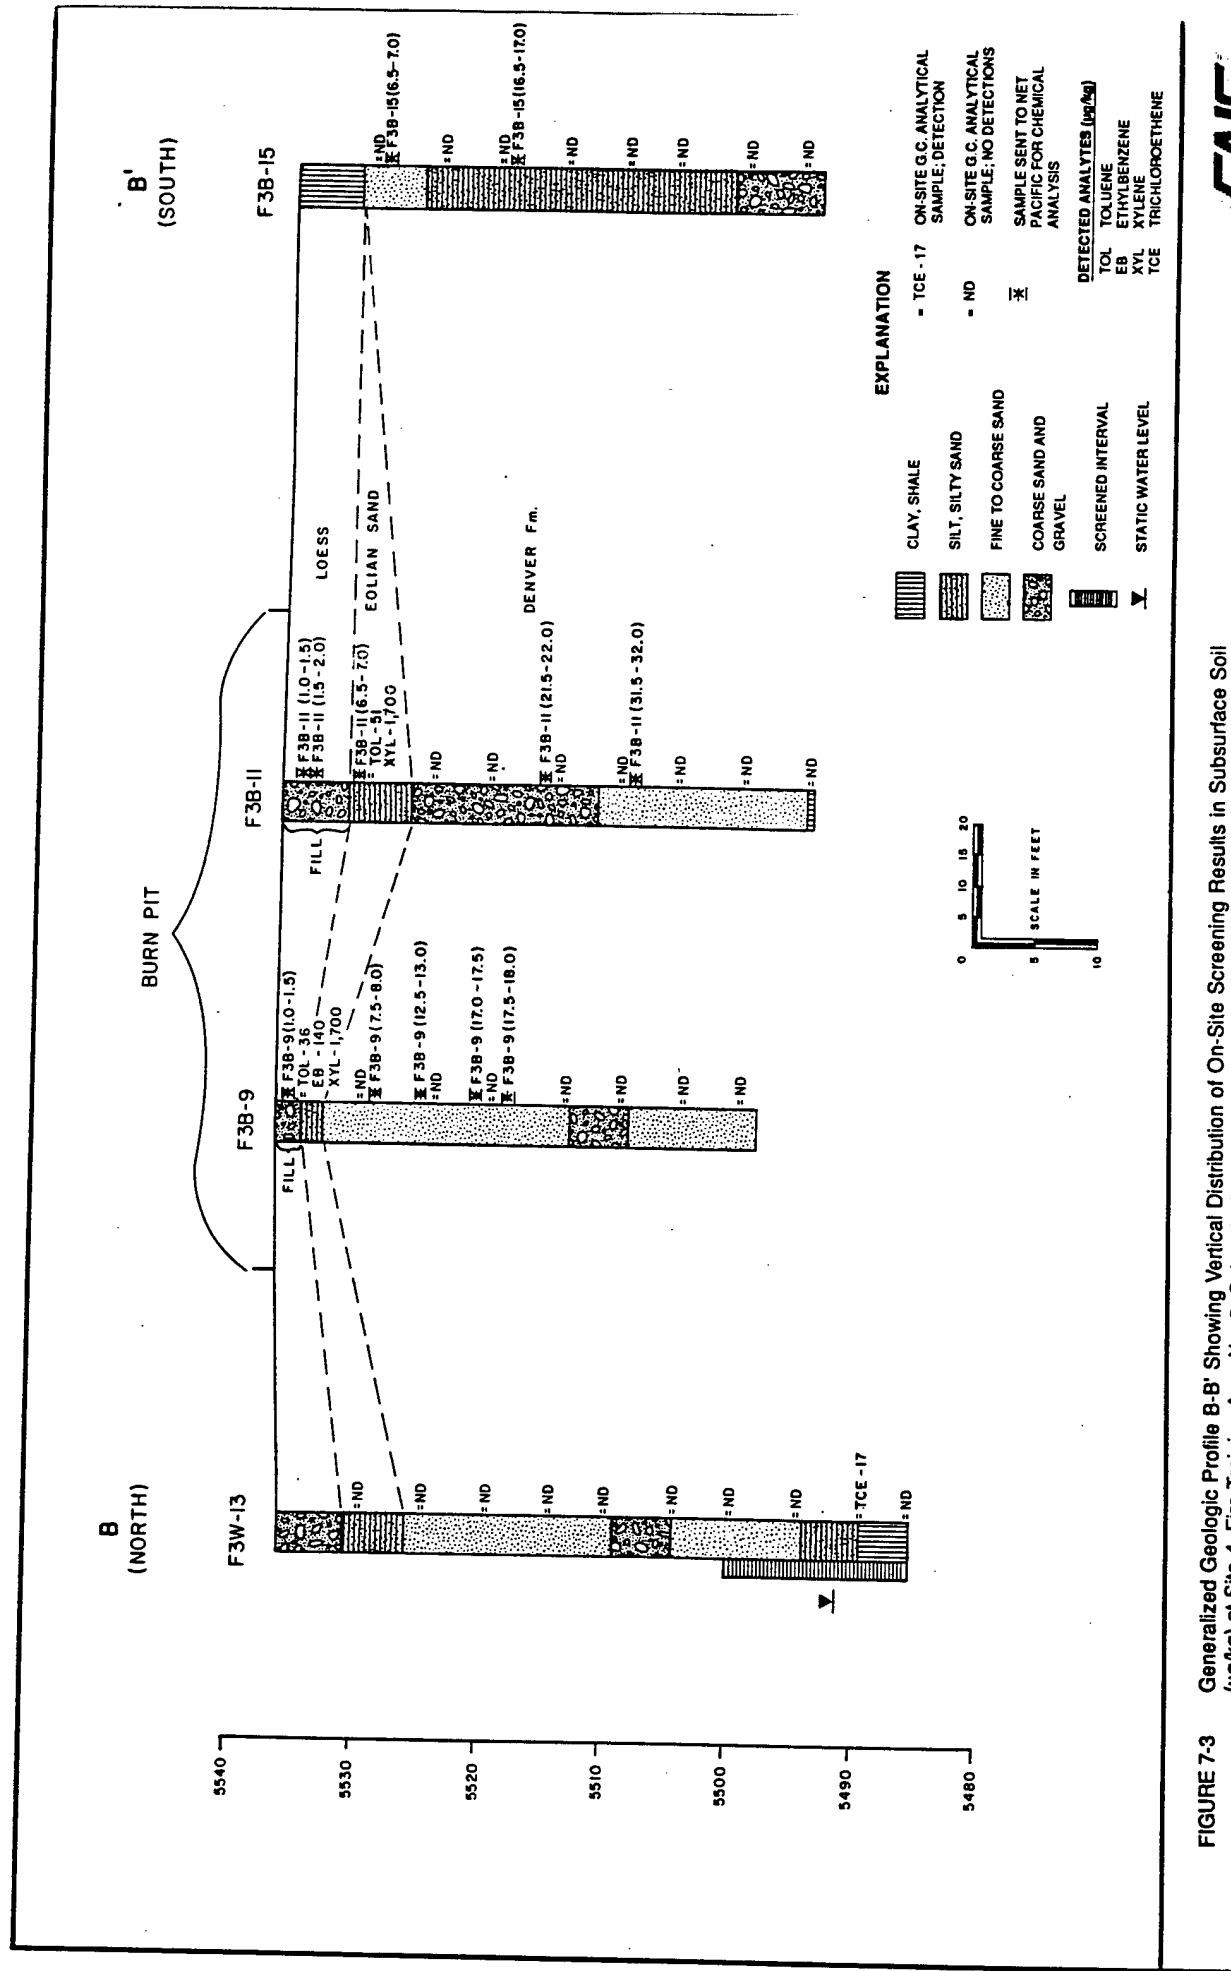
The results of the on-site GC screening of soils showed elevated concentrations of toluene, ethylbenzene, xylene, and methylene chloride in soil borings (F3B-9, 11, 12, and 14) within the burn pit area. The following is a list of ranges for the five organic compounds screened on-site with the GC; toluene (<5 - 1,600 $\mu\text{g}/\text{kg}$), ethylbenzene (<5 - 1,600 $\mu\text{g}/\text{kg}$), xylene (<5 - 13,000 $\mu\text{g}/\text{kg}$), methylene chloride (<20 - 8,800 $\mu\text{g}/\text{kg}$), and TCE (<5 - 15 $\mu\text{g}/\text{kg}$). The results for the borehole samples screened on-site are shown on cross-sections B-B', C-C', and D-D' (Figures 7-3, 7-4,

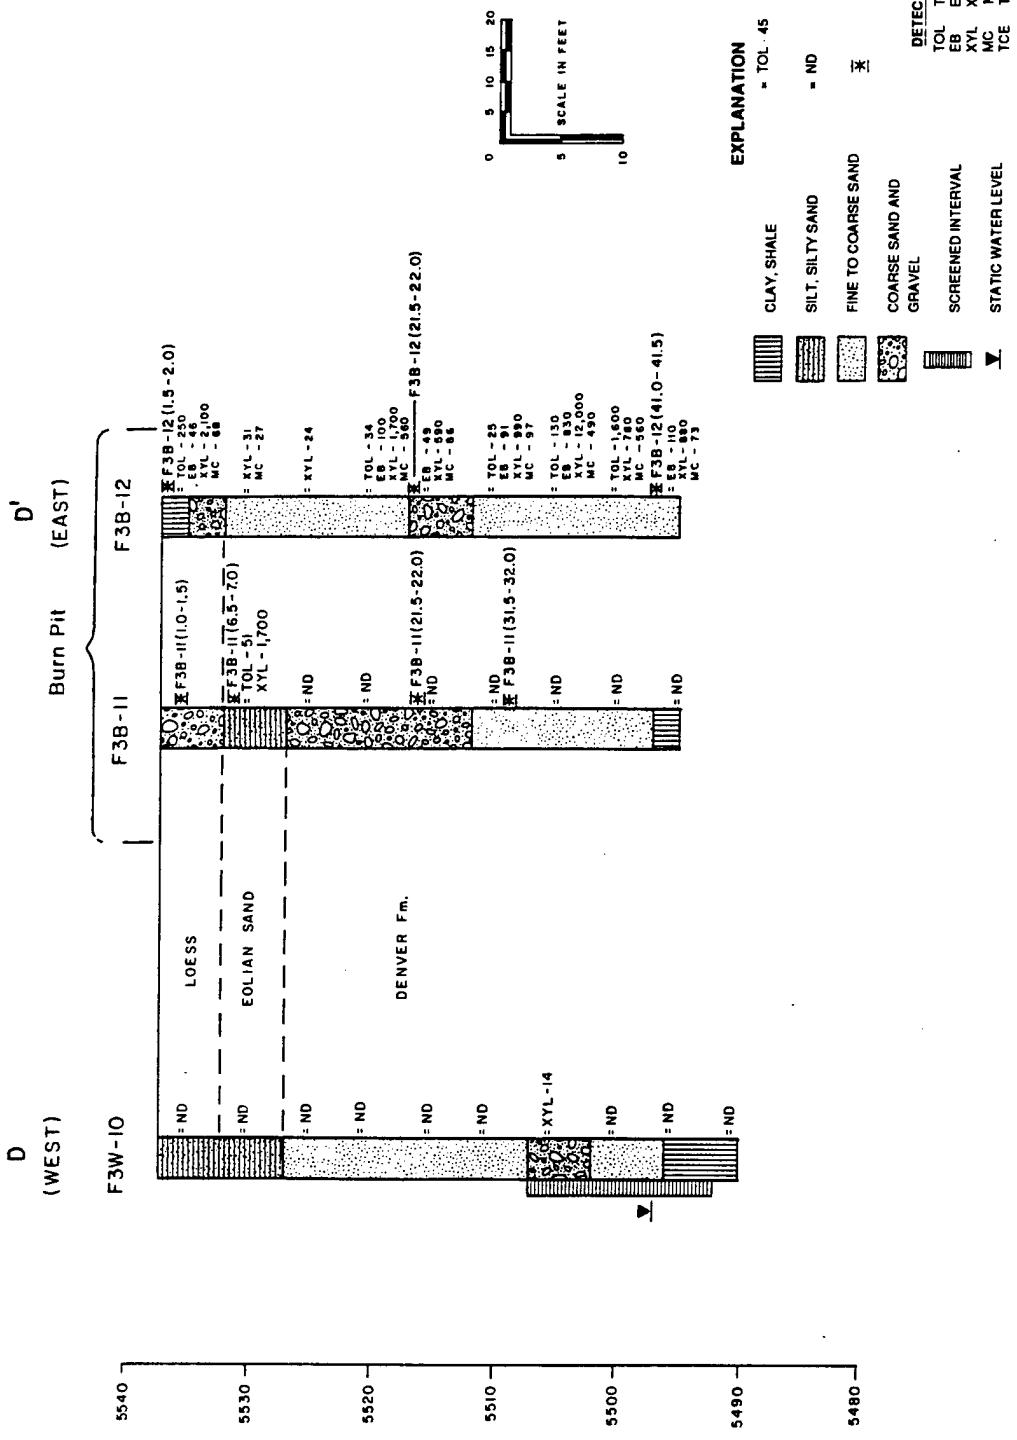
FIGURE 7-5 Generalized Geologic Profile D-D' Showing Vertical Distribution of On-Site Screening Results in Subsurface Soil ($\mu\text{g}/\text{kg}$) at Site 4, Fire Training Area No. 3, Colorado Air National Guard, Aurora, Colorado.

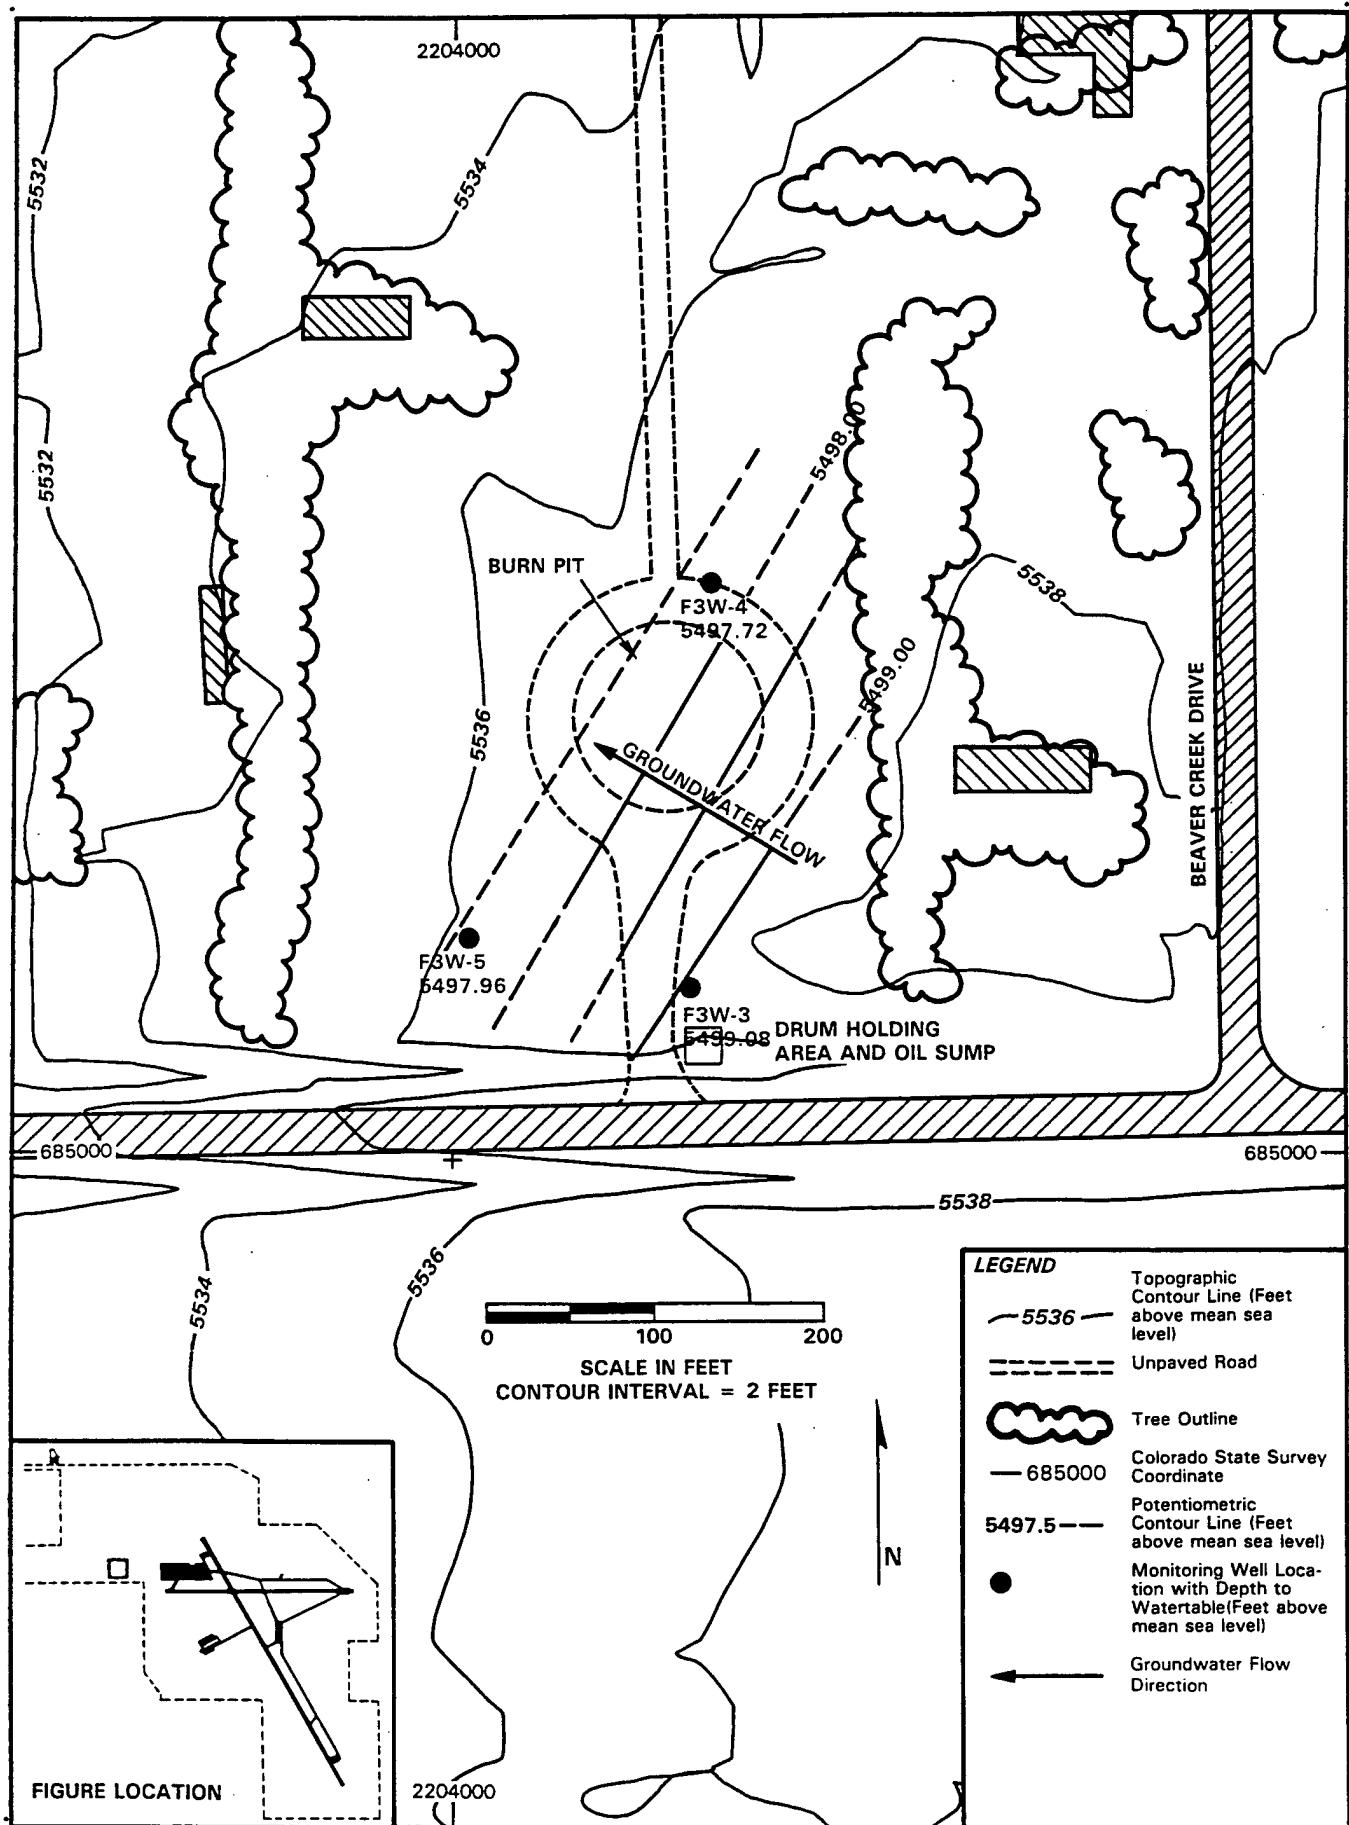
Figure 7-6 Potentiometric Surface Contour Map of Site-4, Fire Training Area No. 3, January 19, 1989, Colorado Air National Guard, Buckley Field, Aurora, Colorado

Static water levels at the site ranged from 38.4 to 39.2 ft BLS (1/20/89) and from 39.9 to 40.7 ft BLS (8/15/91). The potentiometric surface maps (Figures 7-6 and 7-7) show that the flow is to the northwest with a hydraulic gradient of approximately 0.0096. This flow direction was unexpected because the potentiometric surface generally mimics topography. The flow direction was originally expected to be to the southwest because of a strong southwestern topographic slope just south of the site. These groundwater-flow patterns indicate that wells F3W-8, 10 and 13 are downgradient; F3W-4 and 5 are cross-gradient and F3W-3 upgradient of the burn pit (source area).

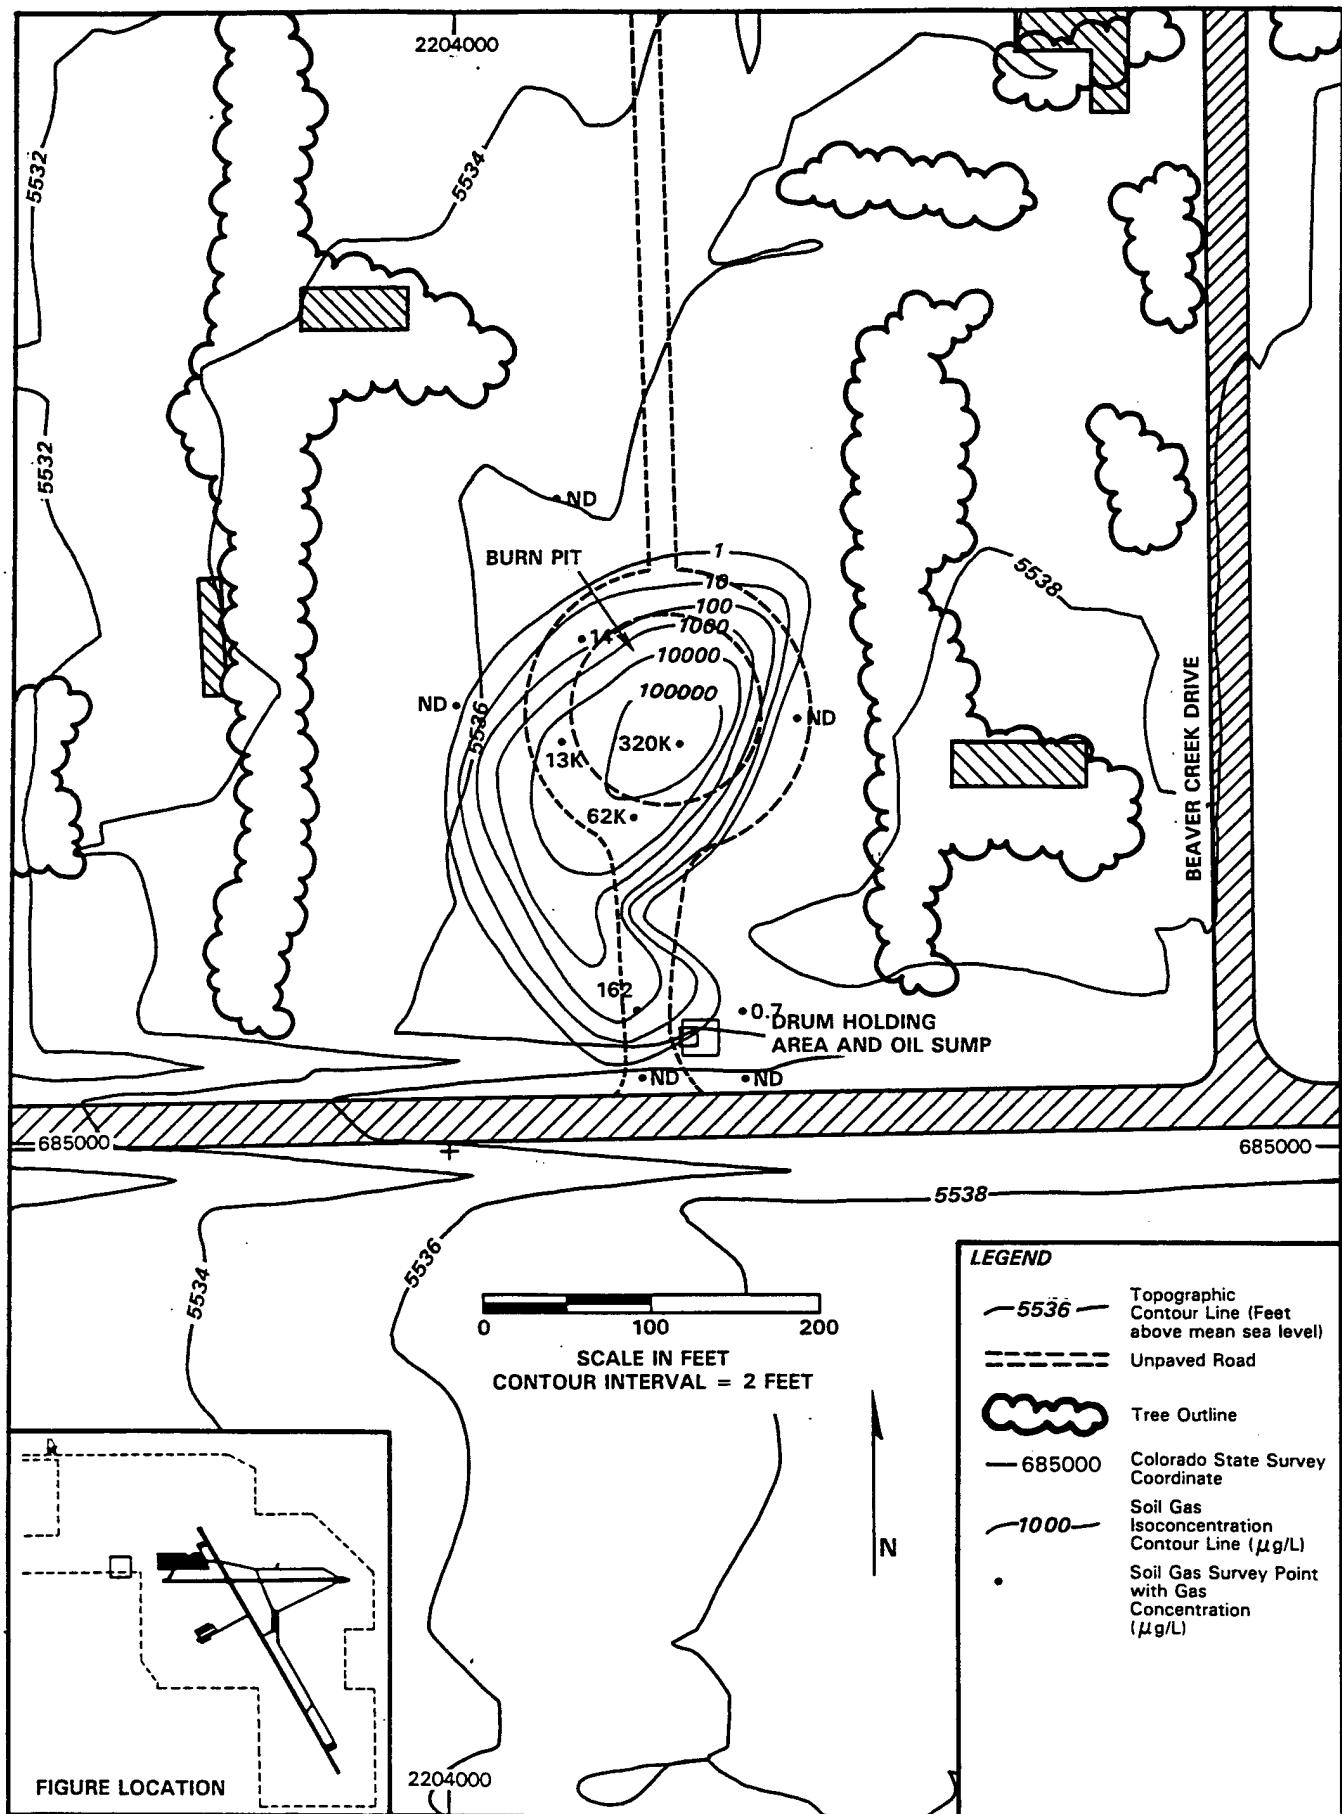
The soil-gas survey data indicate the presence of a 170 foot by 260 foot area of petroleum-related hydrocarbon contamination. The contamination is centered in the burn pit area, with the long axis trending south in the direction of the waste fuel storage area at the site. The area of soil contamination within the burn area was further defined by five soil borings. All five borings drilled within the burn area showed high levels of volatile and semivolatile contamination at the surface, which decreased with depth. Results from the laboratory analysis of borehole soil samples showed that soil contamination extended to 22.0 ft BLS in F3B-12. However, the on-site GC results showed that soil contamination had extended to 41.5 and 36.5 ft BLS in F3B-12 and F3B-14, respectively. Analysis of samples from soil borings outside the burn area (F3B-7 and F3B-15) showed low levels of petroleum hydrocarbon contamination present only to a depth of 2 ft (F3B-7). Deeper samples within both borings showed no site-related contamination. The monitoring well borehole (F3W-4) installed adjacent to the burn pit showed elevated levels of petroleum related contamination to a depth of 40 ft. Other monitoring well borehole samples showed no evidence of any site-related contamination.

Four sampling locations at Site 4 showed elevated total hydrocarbon concentrations (167 to 320,000 $\mu\text{g/l}$). Figure 7-8 shows a contour plot of concentrations of total hydrocarbons around Site 4. The plot shows an area of potential soil contamination, measuring approximately 170 by 260 ft, located directly under and adjacent to the burn pit perimeter. Benzene was also detected at five sampling locations, ranging in concentration from 4 to 70,000 $\mu\text{g/l}$. Benzene is a component of fuel, and it correlated well with the total hydrocarbon results. Toluene and total xylenes were detected, but concentrations were not quantified because of high sample detection limits.

Figure 7-8 Soil Gas Isoconcentration Contour Map of Total Hydrocarbons for Site-4, Fire Training Area No. 3, Colorado Air National Guard, Buckley Field, Aurora, Colorado

The results of the five soil borings drilled within the burn area clearly show that soil contamination is present to 22.0 ft BLS. A baseline public health evaluation indicates that there is no significant carcinogenic or noncarcinogenic risk associated with the soil contamination at the site. However, the mean levels of the contaminants used in the risk calculation also include those soil samples taken from outside the burn area (F3B-7 and F3B-15). Therefore, a nontime-critical source removal action for the soil within the burn pit is recommended for Site 4.
